RESULTS OF  
URANIUM DIOXIDE - TUNGSTEN  
IRRADIATION TEST AND  
POST-TEST EXAMINATION

*by John F. Collins, Claude E. deBogdan,  
and Dominic C. DiIanni*

*Lewis Research Center  
Cleveland, Ohio 44135*

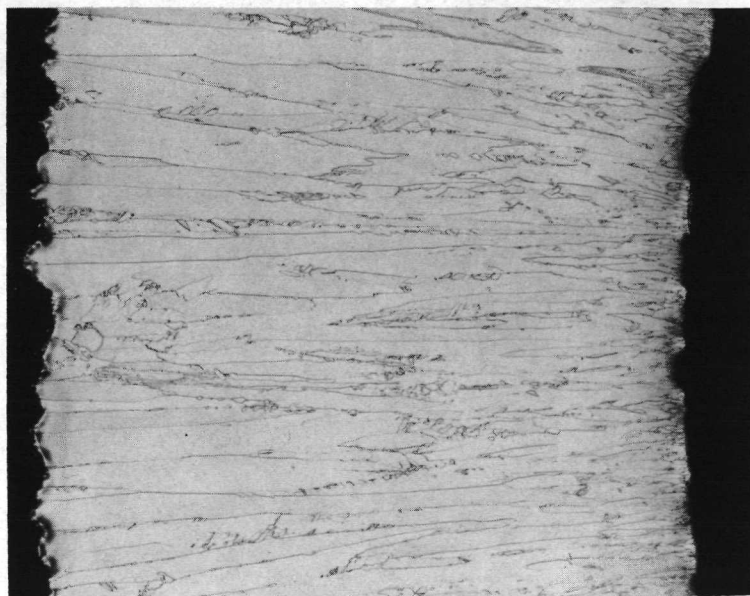
Figure 3. - Microstructures of 0.1016-centimeter (0.040-in.) wall of chemically vapor deposited tubing in as-received condition and after 2500° C swelling test. (Reduced 8 percent in printing.)

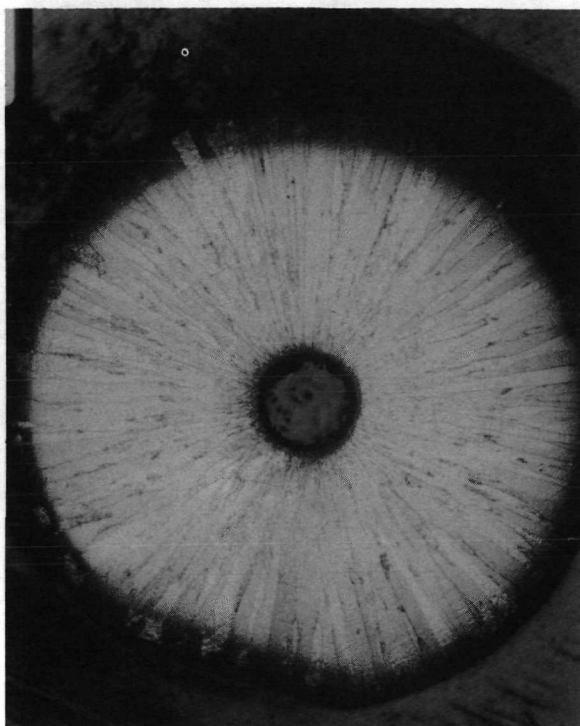
Figure 4. - Microstructures of chemically vapor deposited tungsten tube used for central vent tube. (Reduced 17 percent in printing.)

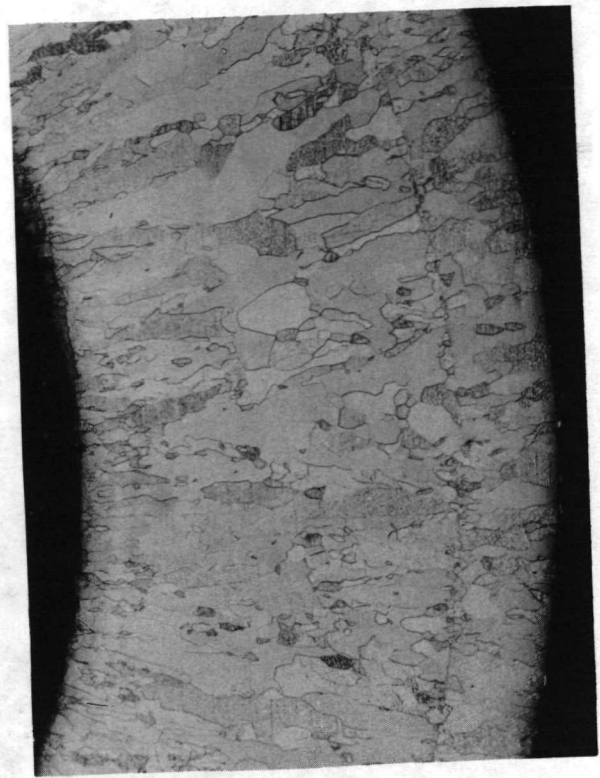
Figure 5. - Microstructures of chemically vapor deposited tungsten - 25-weight-percent rhenium tubing used for stem.  
(Reduced 10 percent in printing.)

Maximum hardness specified was 475 DPH under a 0.0098-newton (100-g) load. The hardness of homogeneous material was measured as 470 DPH as-received and 410 DPH after 2500<sup>0</sup> C swell test. Metallographic examination of the as-received tubing revealed inhomogeneity in the form of a layered microstructure resulting from incomplete mixing of the WF<sub>6</sub> and ReF<sub>6</sub> gases before deposition. The microstructure is shown in figure 5. After the homogenization heat treatment at 2000<sup>0</sup> C for 2 hours, the material was not completely homogeneous, since layers were still present as shown in figure 5. After the 2500<sup>0</sup> C swelling test, the structure was homogeneous and free of sigma phase. This structure had a grain size of ASTM 7.4 to 7.7 and a microhardness of 410 DPH. The stem tube was treated at 2500<sup>0</sup> C for 1 hour for complete homogenization. The fabricated stem tube (175A8674) was 0.355-centimeter (0.140-in.) in outside diameter, 0.211-centimeter (0.083-in.) in inside diameter, and 1.461 centimeters (0.575-in.) long.

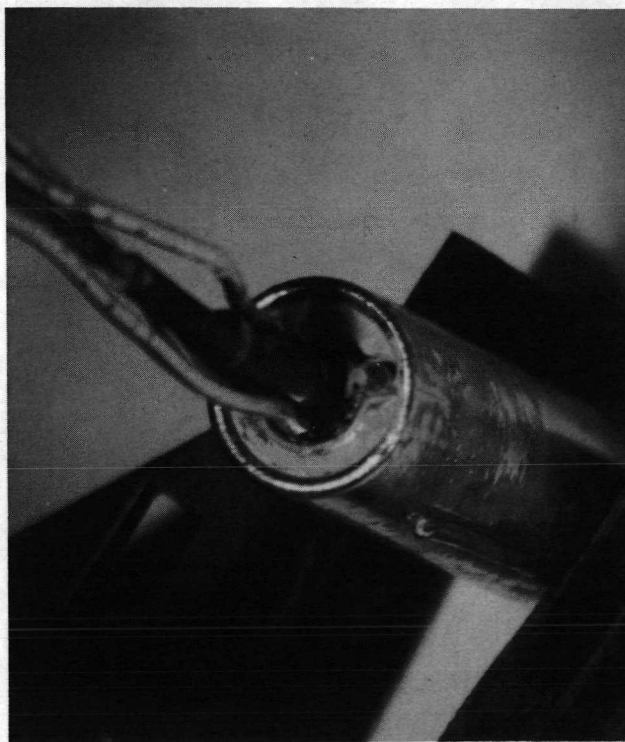
Figure 18. - Top end of steel capsule number 2 showing nickel-manganese braze around thermocouples.

The nickel-manganese braze alloy around the thermocouples at the top of the capsule showed evidence of corrosion by the reactor water, but it had not deteriorated enough to allow a leak into the capsule. This brazed area is shown in figure 18.

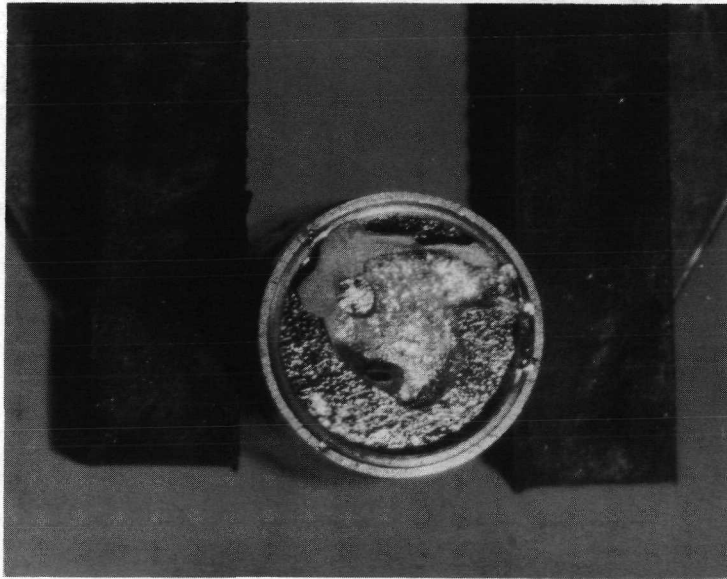
Figure 21. - Remains of niobium heat shields stuck to bottom of fuel specimen.

Re-examination of the interior of the stainless-steel container revealed that parts of the three niobium heat shields in the bottom of container were missing. As part of the subsequent metallographic examination, the bottom of the steel container was filled with epoxy and was sectioned longitudinally and polished to examine the remains of the heat shields and molybdenum retainer ring. This revealed that the molybdenum ring was intact but that the three niobium heat shields adhered to the bottom of the catcher plate. It was concluded that the niobium heat shields had reacted with impurities ( $N_2$ ) in the helium-argon cover gas. When the thermocouple stem broke during irradiation and the specimen dropped down to the bottom of the containment can, the contaminated niobium heat shields apparently became bonded to the bottom catcher plate of the specimen.

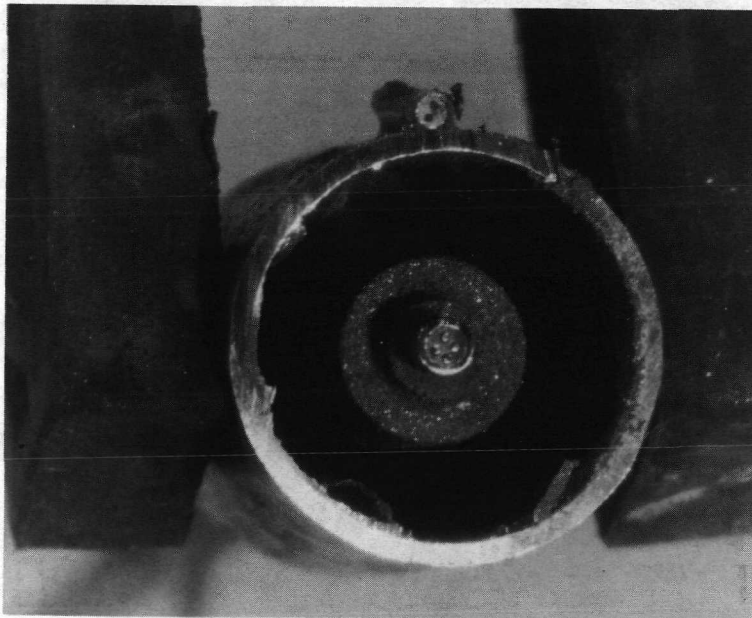
Figure 22. - Top section of steel container showing crystalline deposit on walls and on thermocouple stem. Gamma scan activity peaks indicated that deposit contained solid fission products.

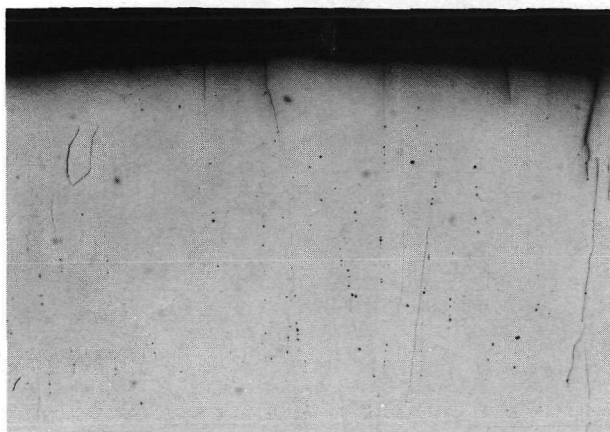
Figure 28. - Microstructure of chemically vapor deposited tungsten cladding near top of fuel specimen, showing retention of original columnar grain structure. (Reduced 26 percent in printing.)

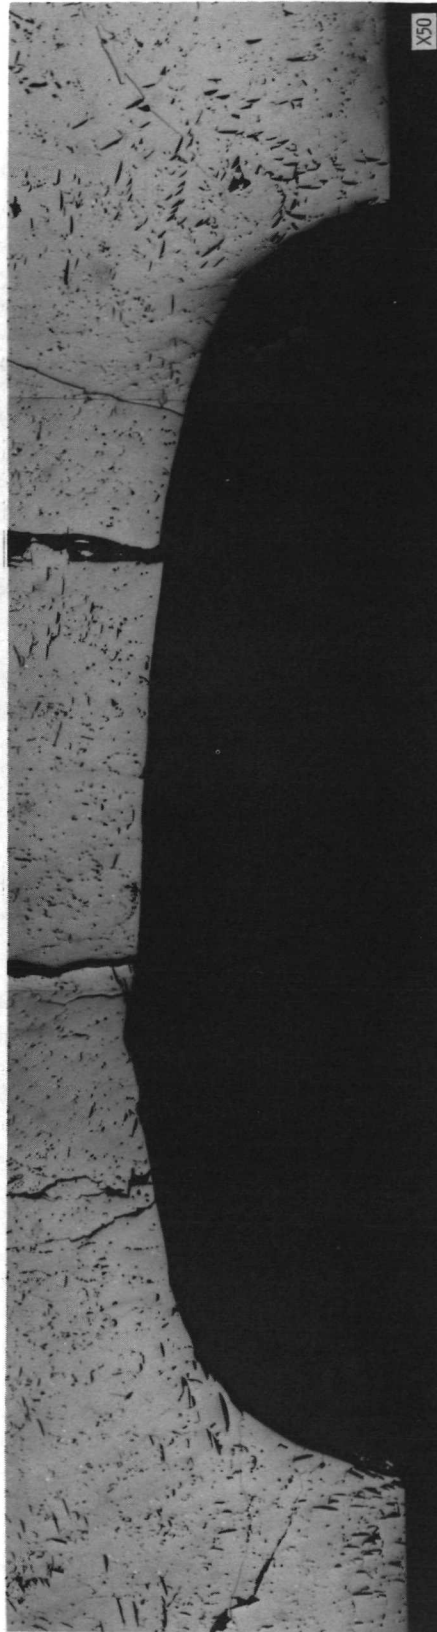
Figure 32. - Microstructure of redistributed uranium oxide fuel under top end cap of clad fuel specimen. Original fuel pellet form is shown on either side (longitudinal section).  
(Reduced 22 percent in printing.)

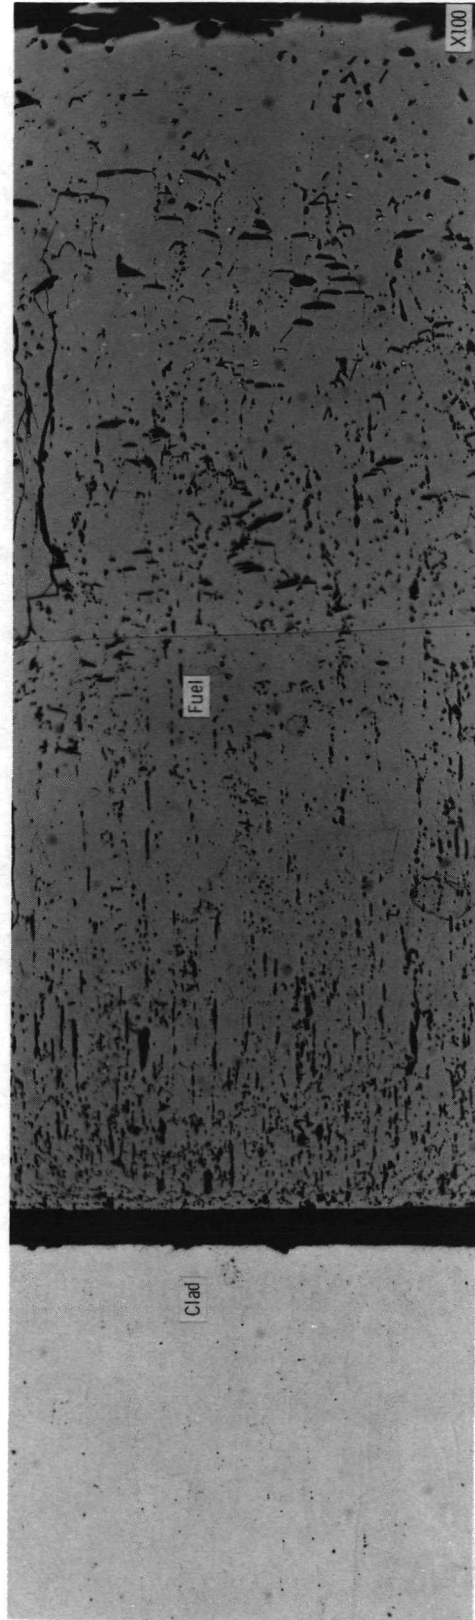
Figure 37. - Montage of longitudinal section of redistributed fuel and chemically vapor deposited tungsten cladding in lower portion of fuel specimen. Note bright metallic phase in fuel near cavity. (Reduced 22 percent in printing.)

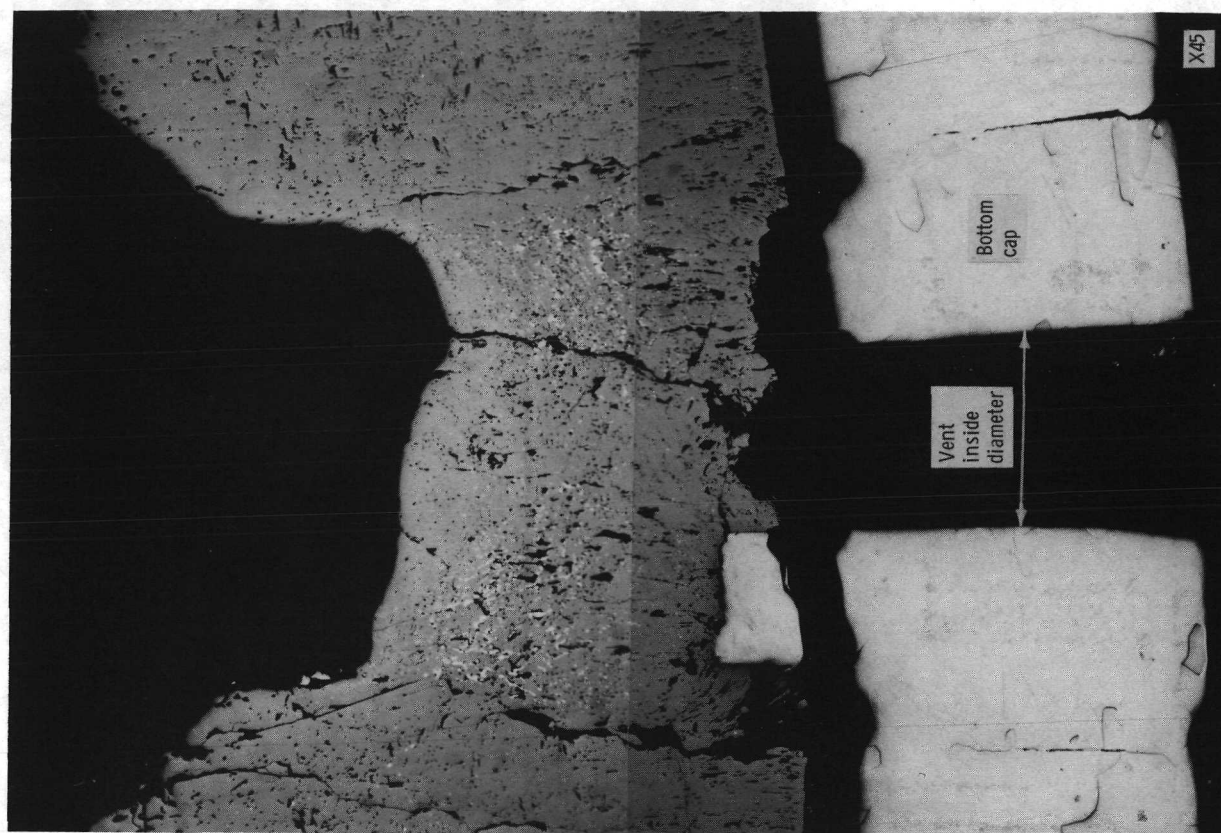
Figure 43. - Bottom end cap with base of vent tube and redistributed fuel bridging the gap where vent tube was before fracture. Note second phase in redistributed uranium dioxide.

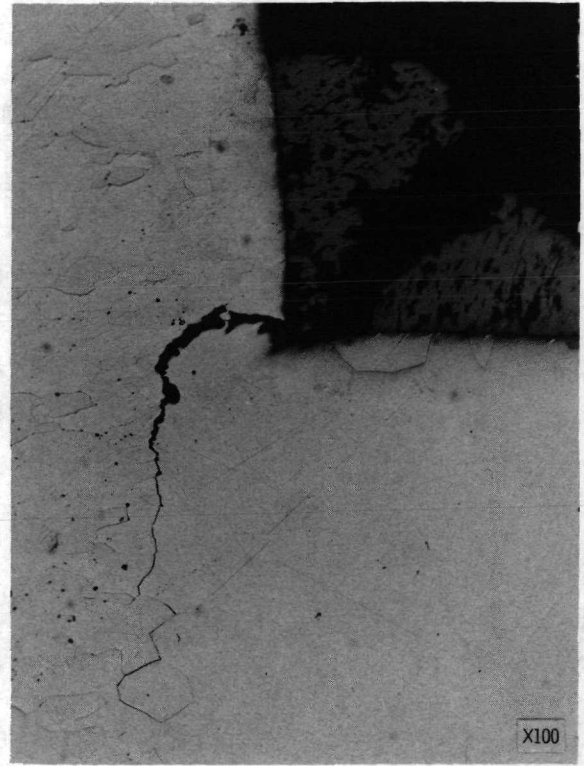
Figure 46. - Section of electron-beam welded joint between chemically vapor deposited tungsten cladding and arc-cast tungsten end cap on side opposite failure showing initiation of cracking from inside corner. (Reduced 8 percent in printing.)

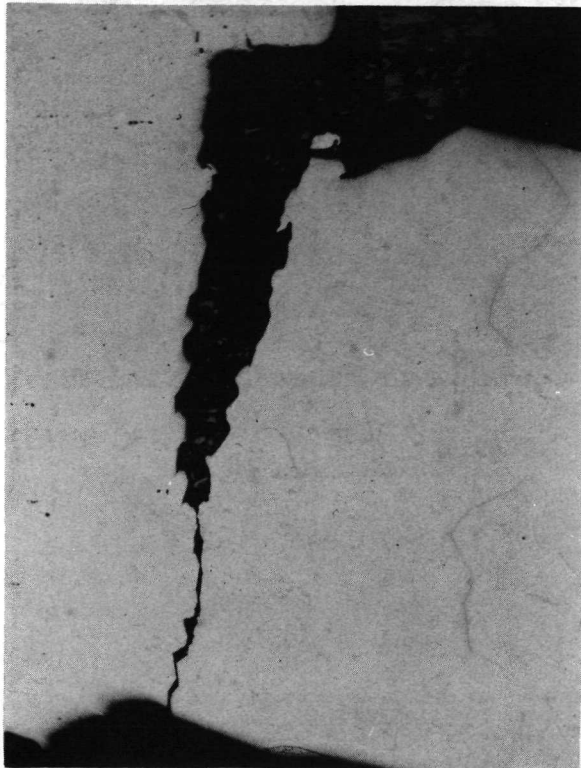
Figure 47. - Ruptured weld joint between bottom end cap and cladding sleeve. End cap was arc-cast tungsten and cladding was chemically vapor deposited tungsten. (Reduced 8 percent in printing.)

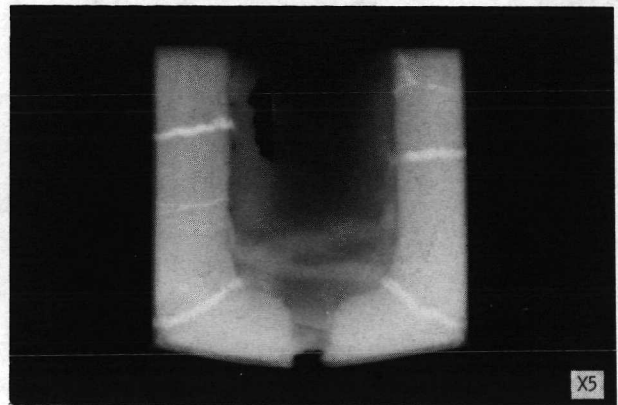
Figure 49. - Gamma autoradiographs of longitudinal section of fuel specimen showing radial burnup gradient. Note bowed bottom end cap and remains of broken vent tube.
